## **URBAN FLOOD IMPACTS, FLOOD WATER QUALITY AND RISK MAPPING OF OLODO AREA, IBADAN, NIGERIA**

### **ABSTRACT**

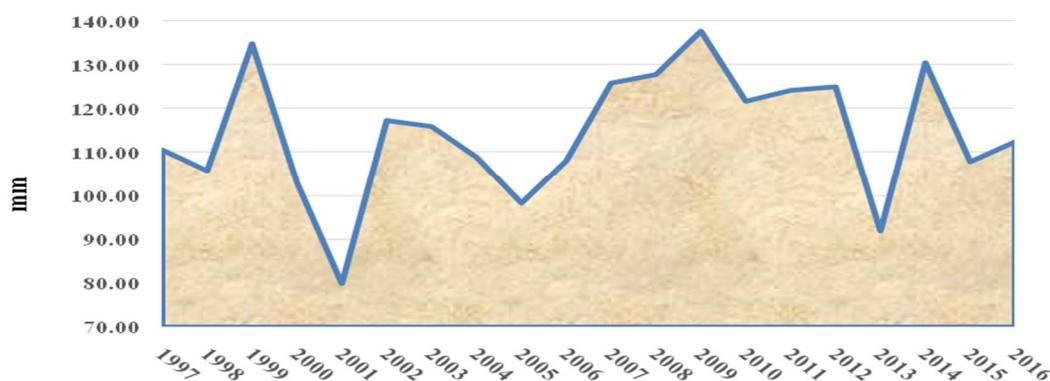
Figure 2: Rainfall Data for the Study Area between 1997-2016

Figure 2 shows the rainfall data for 16 years (1997-2016). Average rainfall in the raining season ranged from 142 mm in April to 190 mm in June 2016, while average temperature ranged from  $24.1^\circ C$  to  $28.6^\circ C$ . Climatic data for the area shows high intensity rainfall leading to the devastating flood in the study area (Figure 2 and 3). Annual rainfall varies between 1997 to 2016 with the peak periods been 1999, and then 2007 to 2012. The amount of rainfall has not changed overtime but the intensity and duration is a major problem leading to flooding. A report by Nigerian Meteorological agencies has indicated considerable signals of a changing climate with variability in rainfall and warmer temperature (Krometis, 2009).

Peak periods of rainfall such as 1999, 2009, 2012, 2013, and 2016 coincided with reported incidences of flooding which great impacts on the people in different parts of the region. According to the National Emergency Management Agency (NEMA), 30 out of Nigeria's 36 states were affected by the 2012 floods, which were termed as the worst in 40 years and the rainfall data showed that 2012 had highest rainfall in the past 20 years (NIMET, 2008). Large amount of water spilled from low-rise river sections resulted into flood affecting several people and their properties in Olodo area. Residential areas were mostly affected by flooding which accounts for the high percentage vulnerability and about thirty houses were swept away by the flood while forty

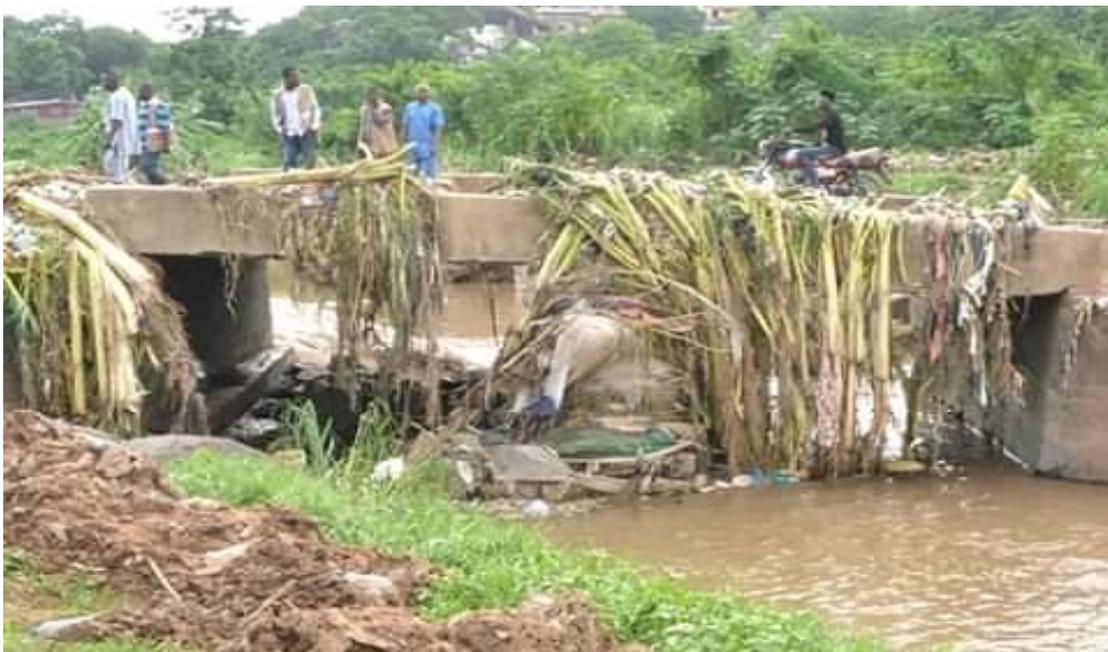
Construction of buildings within setbacks, poor floodplain and river channel management, the use of the rivers and drainage channels for solid waste disposal (Figure 5) have resulted in the inundation of many parts of the study area during heavy rainfall (Adelekan, 2016). Recently, the National Emergency Management Agency (NEMA) reported that on June 20, 2017, over 300 houses are affected by the flooding that accompanied the five-hour downpour in Ibadan, which include houses in the Olodo area. Majority of the buildings were illegally constructed without approvals from the authority. Observation and investigations

**Figure 5: Blockage of River Channel with solid wastes**

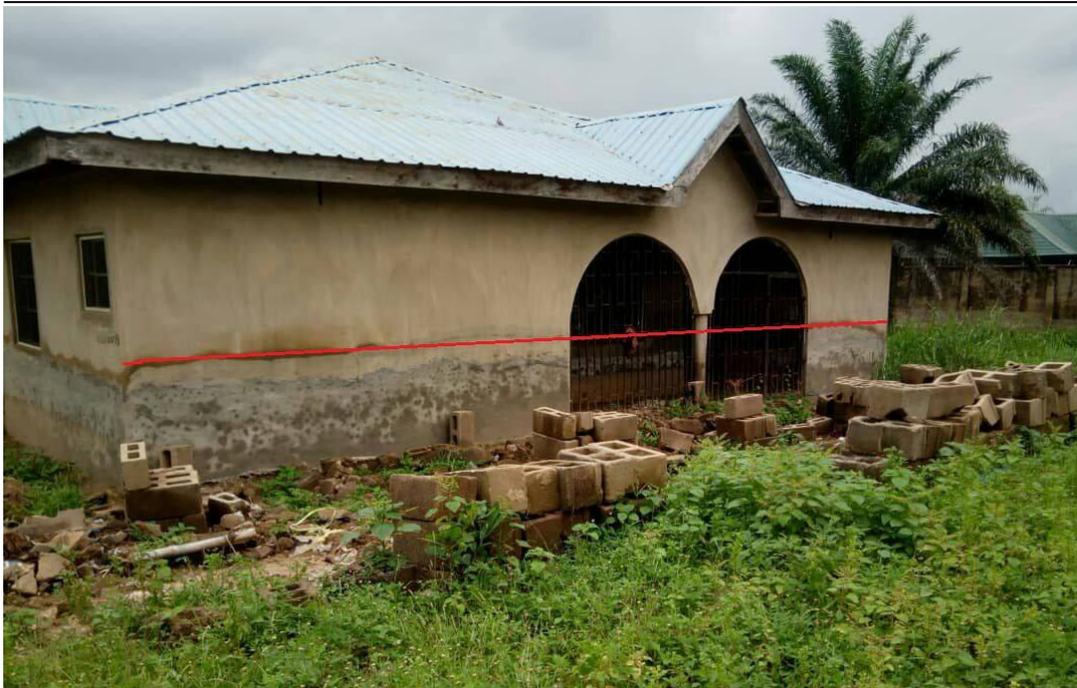
Figure 6 shows one of the houses affected by the inundation with the flood height on the walls. This building is one of the illegal and unapproved houses build along the floodplain of the river. The building

blocked the river channel thus constricting the flow of the river. It is an abandoned building now due to constant threat of inundation by floodwater.

**Figure 6: Flood height after the flood**
